USATEA REPORT 66-11

Engineering Report

# PERSHING TRANSPORTABILITY STUDY

Foreign Railways, Vol. III of IV

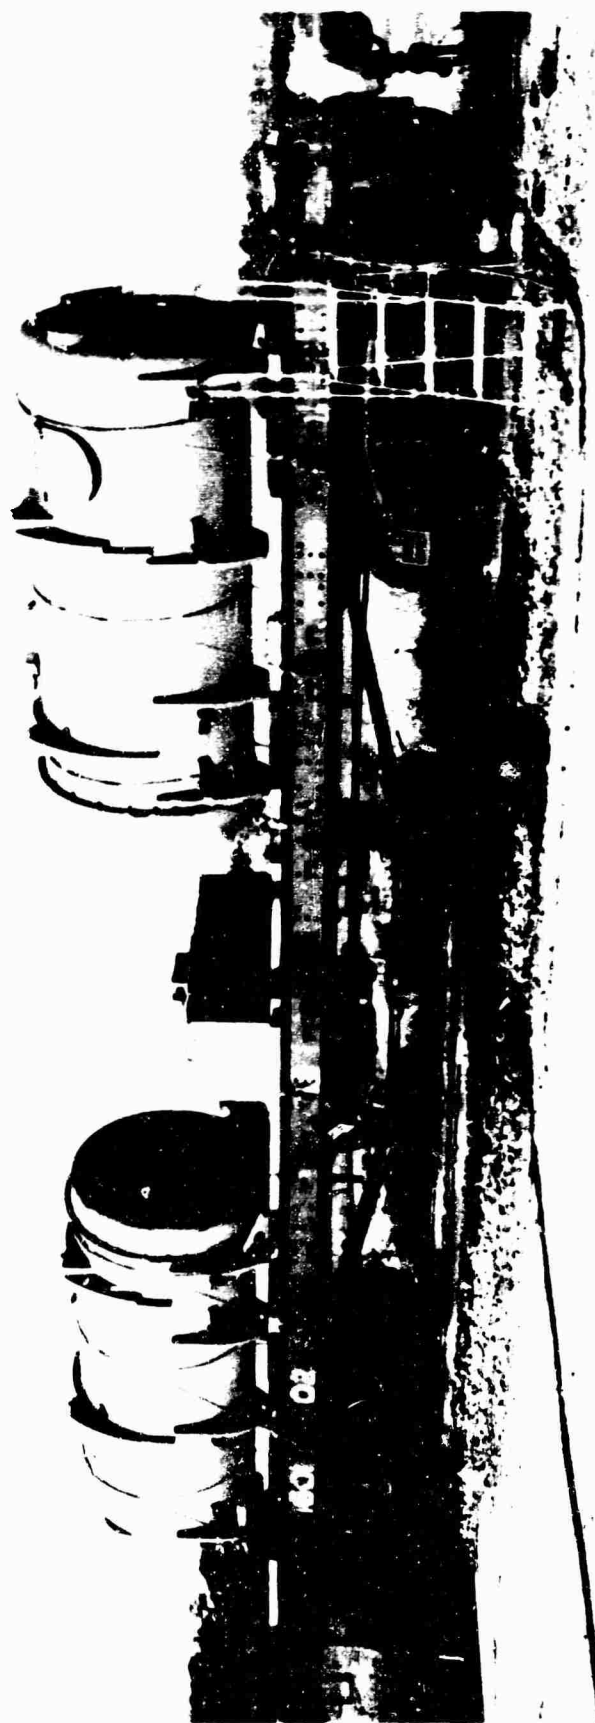
Figure 1. R&D XM 475 and XM 476 Containers on Test Car (Gross Weight, 47,400 Pounds).

Two Research and Development containers, an XM 475 and an XM 476, were used in the study. A simulated XM 474 container was used to obtain the normal load transfer into the blocking arrangement. Figure 1 shows the containers loaded on the test car. Other Pershing missile containers have a similar geometry and construction; therefore, the results of the study are equally applicable to them, except for correlating the spring constants between the R&D container and the production model.

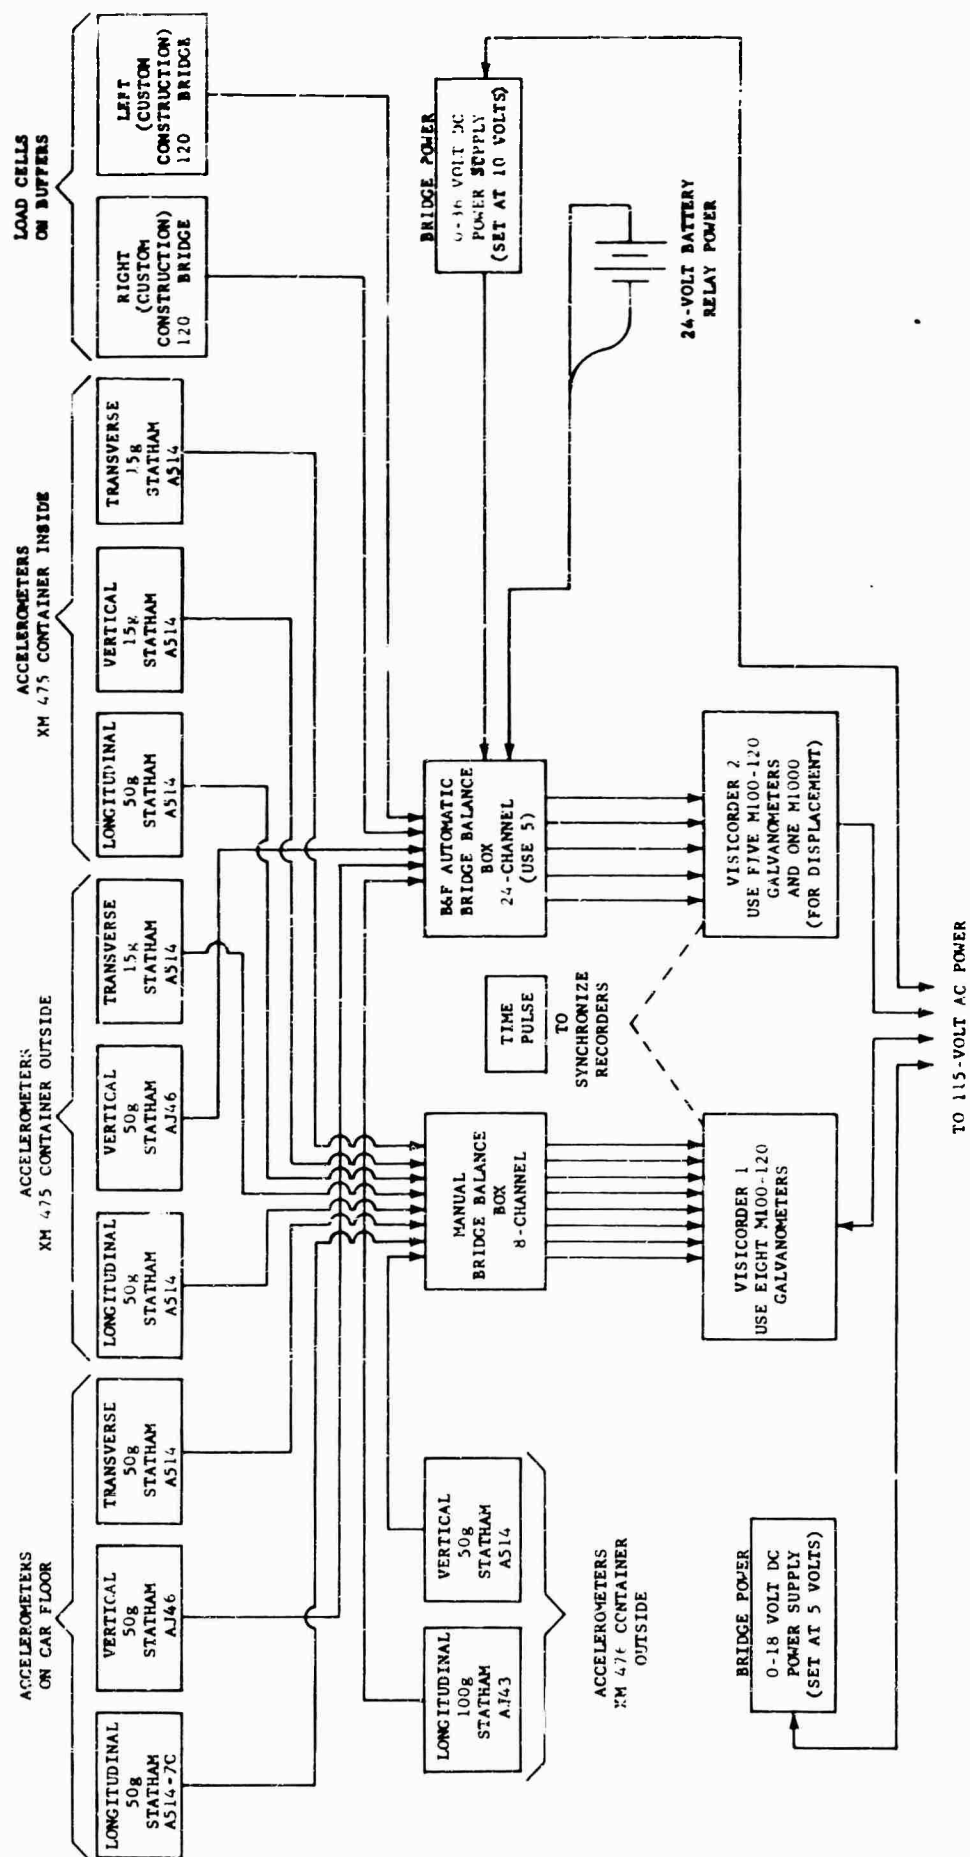
Figure 2. Schematic of Instrumentation.

The electronic instrumentation, illustrated schematically in Figure 2, consisted of strain gage accelerometers having a frequency response of from 0 to 280 cycles per second, and an automatic electrical recording system.

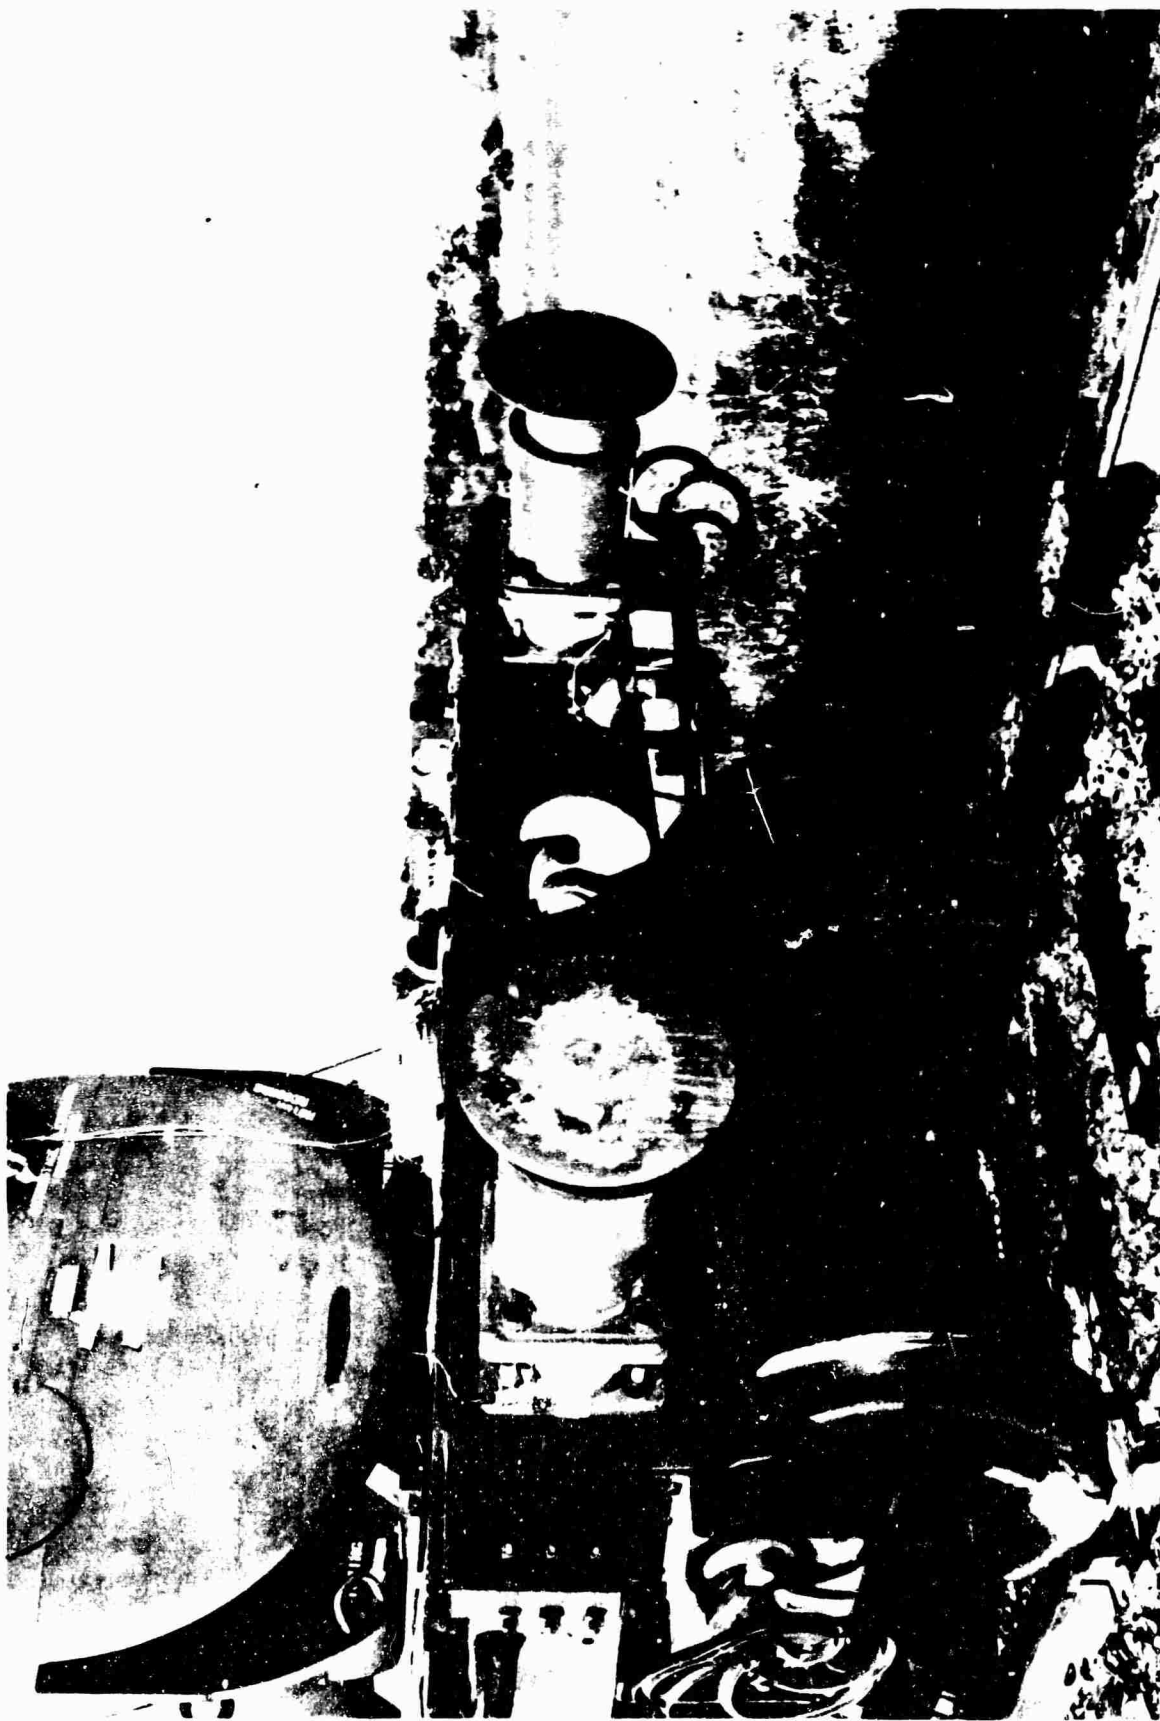
Figure 3. Dynamometers for Measuring Impact Forces.

Specially designed dynamometers for measuring impact forces into the transport system were located between each side buffer on one end of the car and the car end sill, as illustrated in Figure 3.

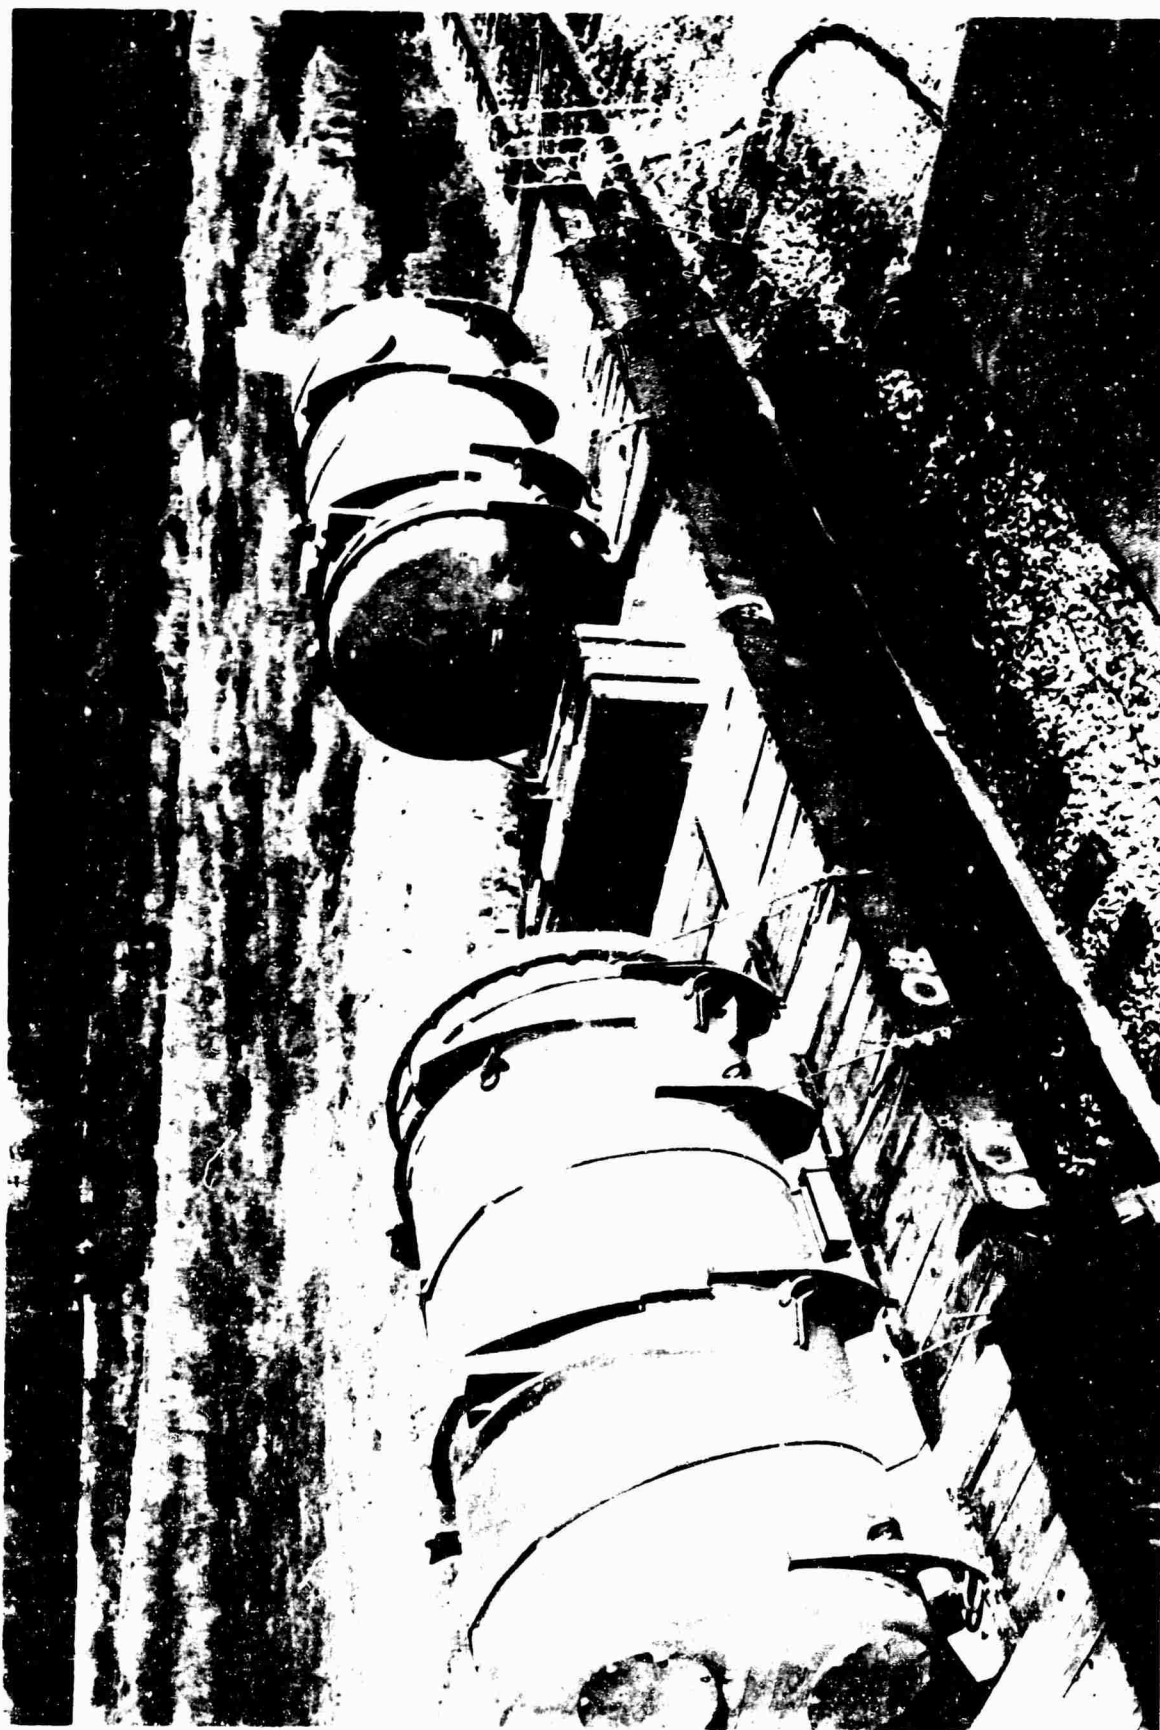
Figure 4. Restraining Procedures Used on Containers.

The loaded test car is illustrated in Figure 4. The XM 475 container (right end of car) was restrained in accordance with page 4 of Savanna Army Depot Drawing No. 5425, Figure 5, except that an additional timber, approximately 2 by 4 inches, was required to fill the space between the forklift receptacles. (The space is 18½ inches wide; the three double 2-by-6-inch timbers specified in the drawing are only 16-7/8 inches wide.) This arrangement provides direct load transfer into the forklift receptacles. One-half-inch-diameter cables were used rather than 2-inch steel strapping, since the latter may not be readily available in overseas theaters.

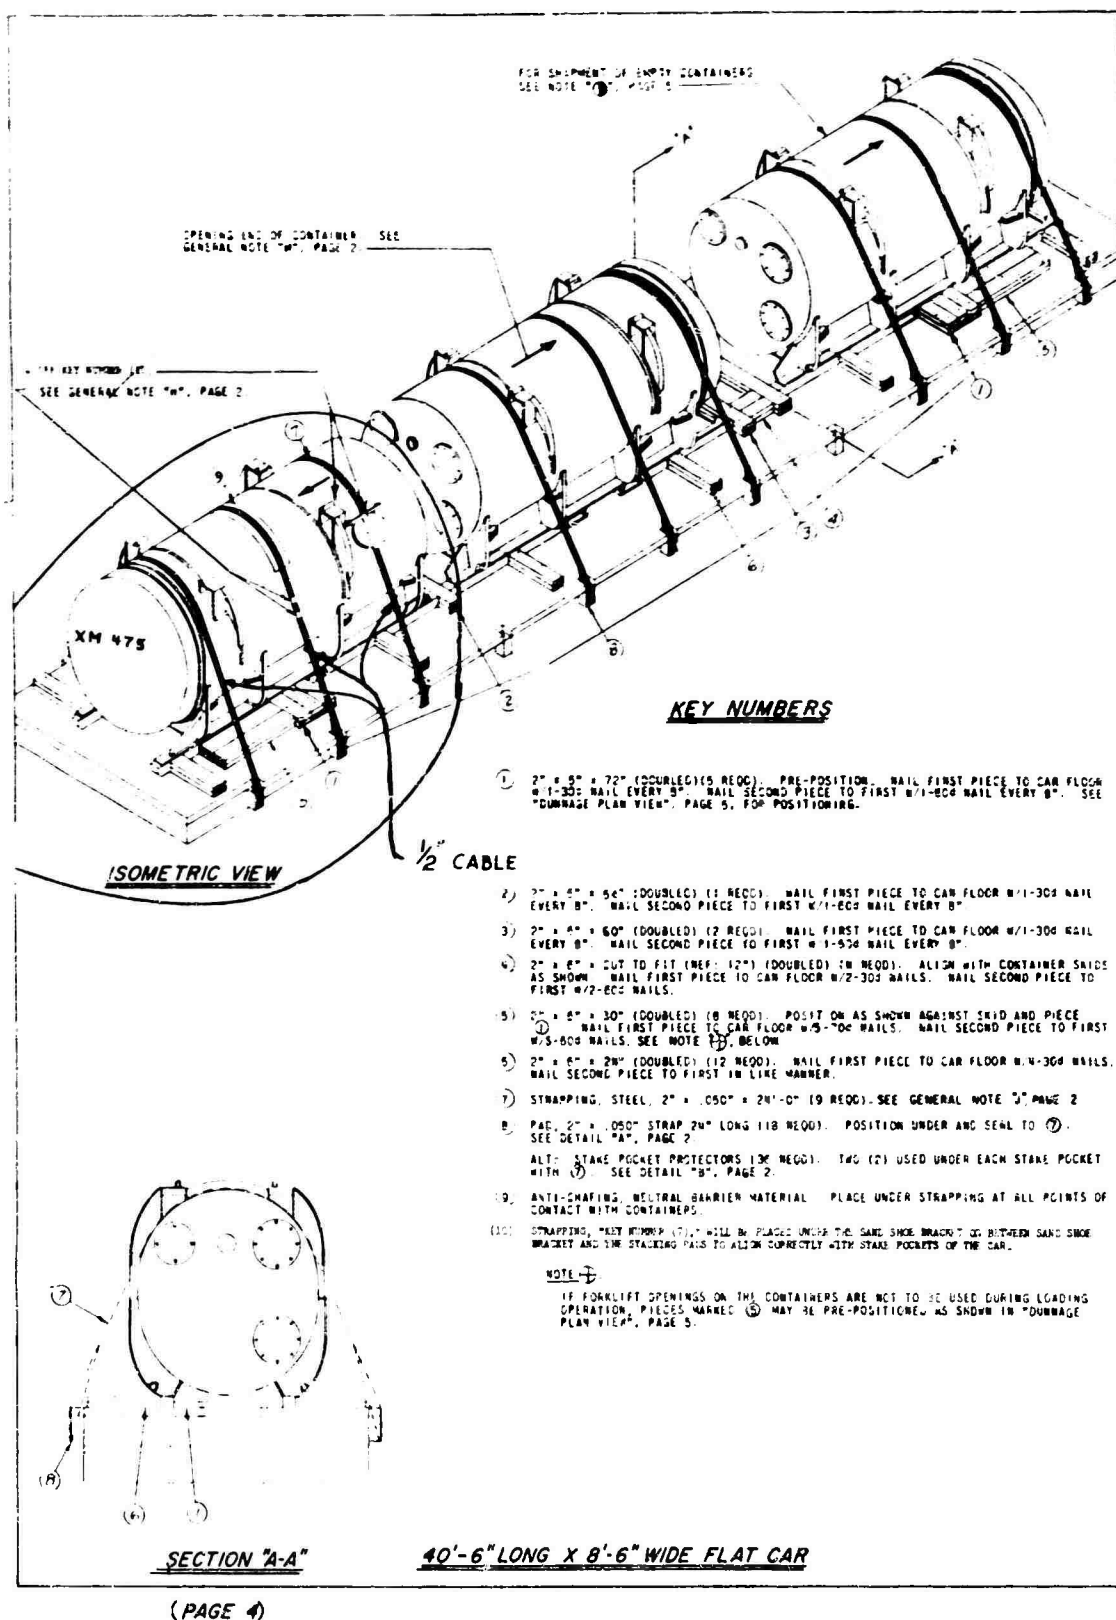
Figure 5. Savanna Army Depot Drawing No. 5425, Page 4.

The restraining arrangement used on the XM 475 container, exhibited on page 4 of Savanna Army Depot Drawing No. 5425 (Figure 5) and more explicitly in Figure 11, sustained the combined dynamic loadings resulting from the 14 railcar impacts (Conditions A and B) without any apparent damage.

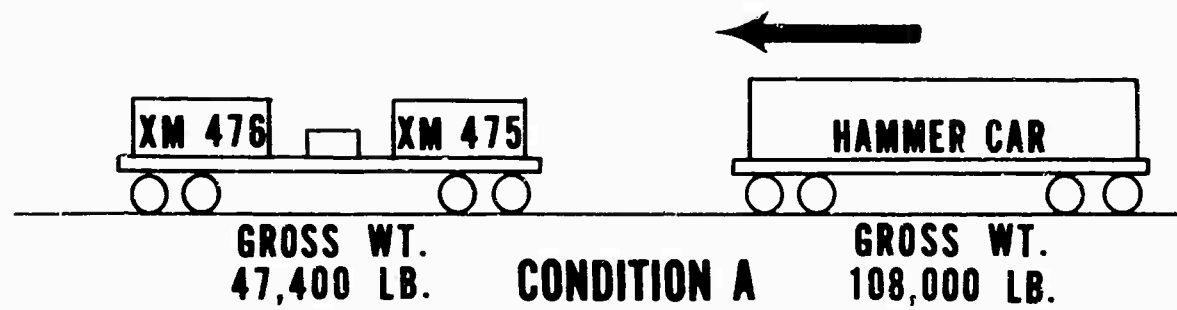
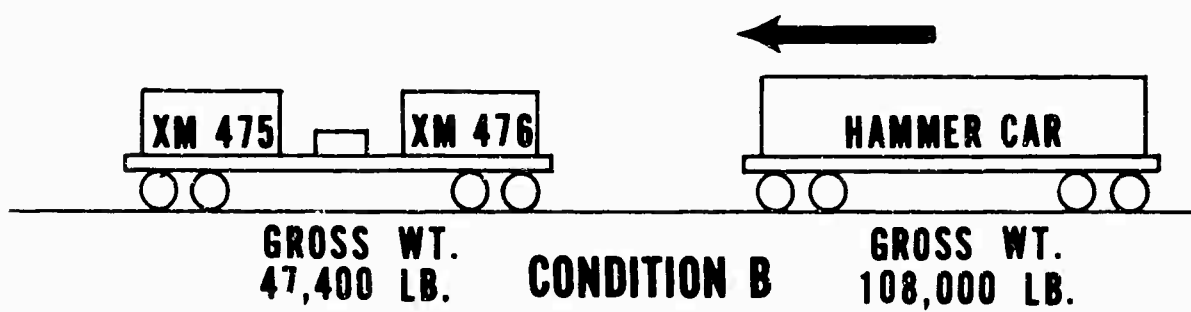
Figure 7. Types of Impacts.

The railcar impacts were conducted as illustrated in Figure 7. The relative positioning of the test equipment (hammer car, test car, and backup cars) is illustrated in Figure 8. Closeup views of the test car, the hammer car, and the first backup car are shown in Figures 4, 9, and 10 respectively.

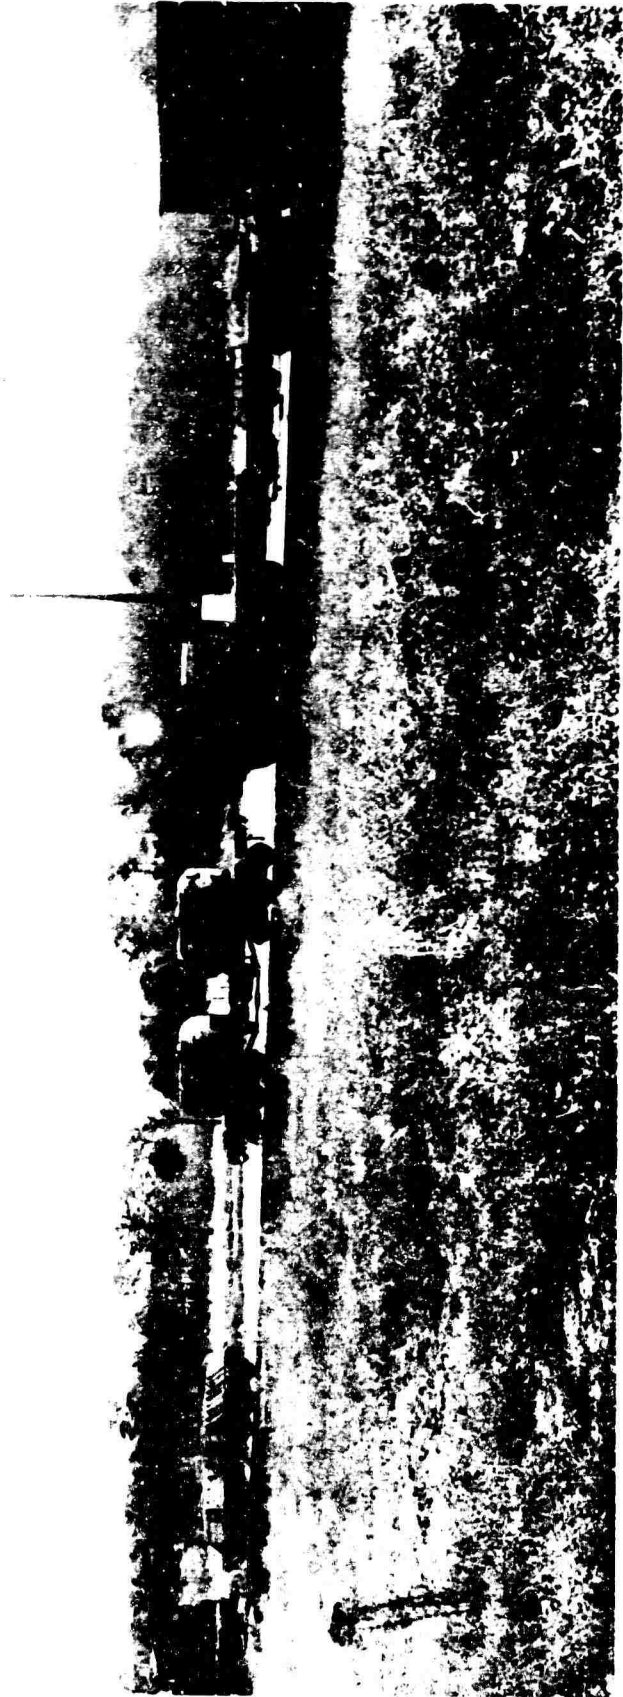
Figure 8. Positioning of Rail Equipment for Impact Tests.

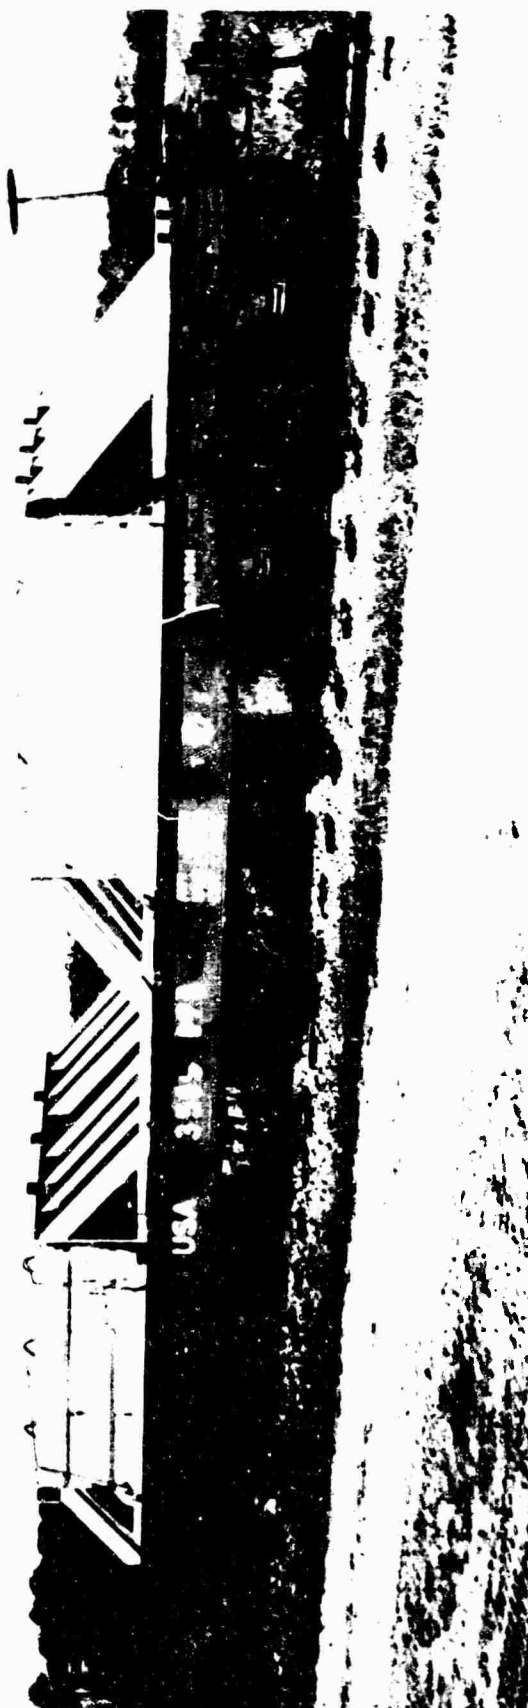
Figure 9. Hammer Car (Gross Weight, 108,000 Pounds).

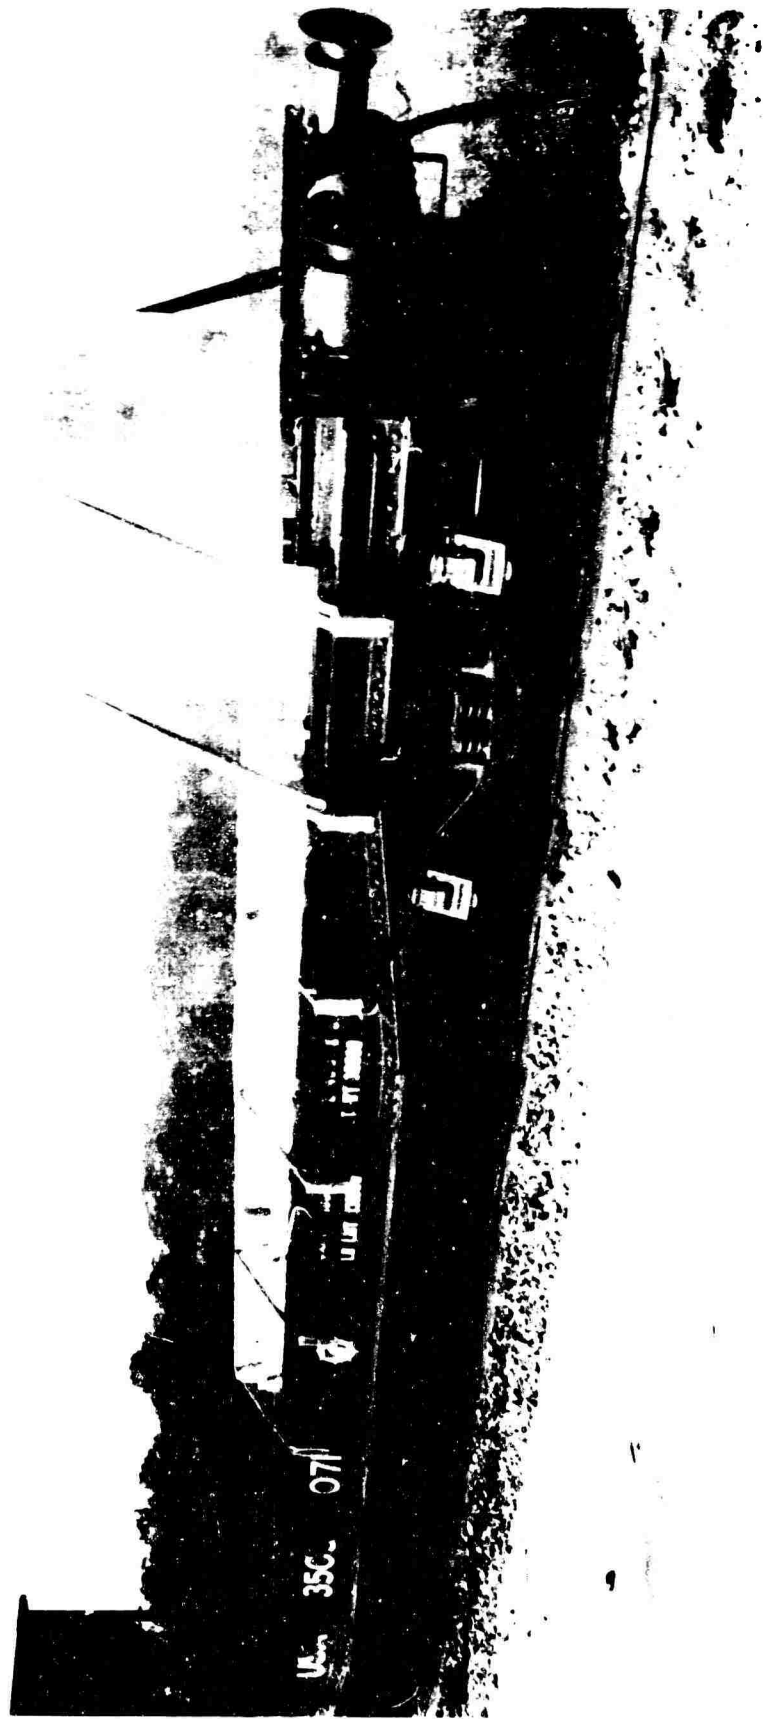
Figure 10. First Backup Car.

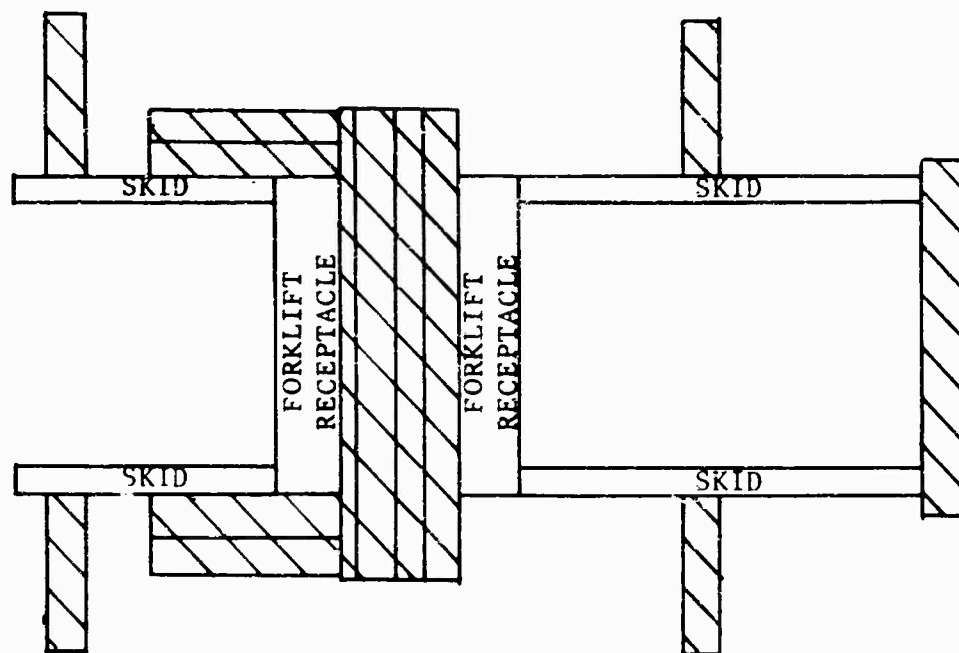
NOTE: Blocking is X-hatched. For details as to size and nailing, see Figure 5.

Figure 11. Blocking Arrangement for XM 475.

4. The restraining arrangement illustrated in Figure 11 has adequate structural integrity to resist longitudinal shock forces of up to 21.4g at 20 milliseconds imposed by the tested foreign railcar under impact velocities varying from 3.9 to 8.5 miles per hour.

Of the two restraining arrangements evaluated, the arrangement shown in Figure 11 provides greater structural integrity since longitudinal loads are transmitted to the base structure through the forklift receptacles rather than through the skids, which are inherently weak.

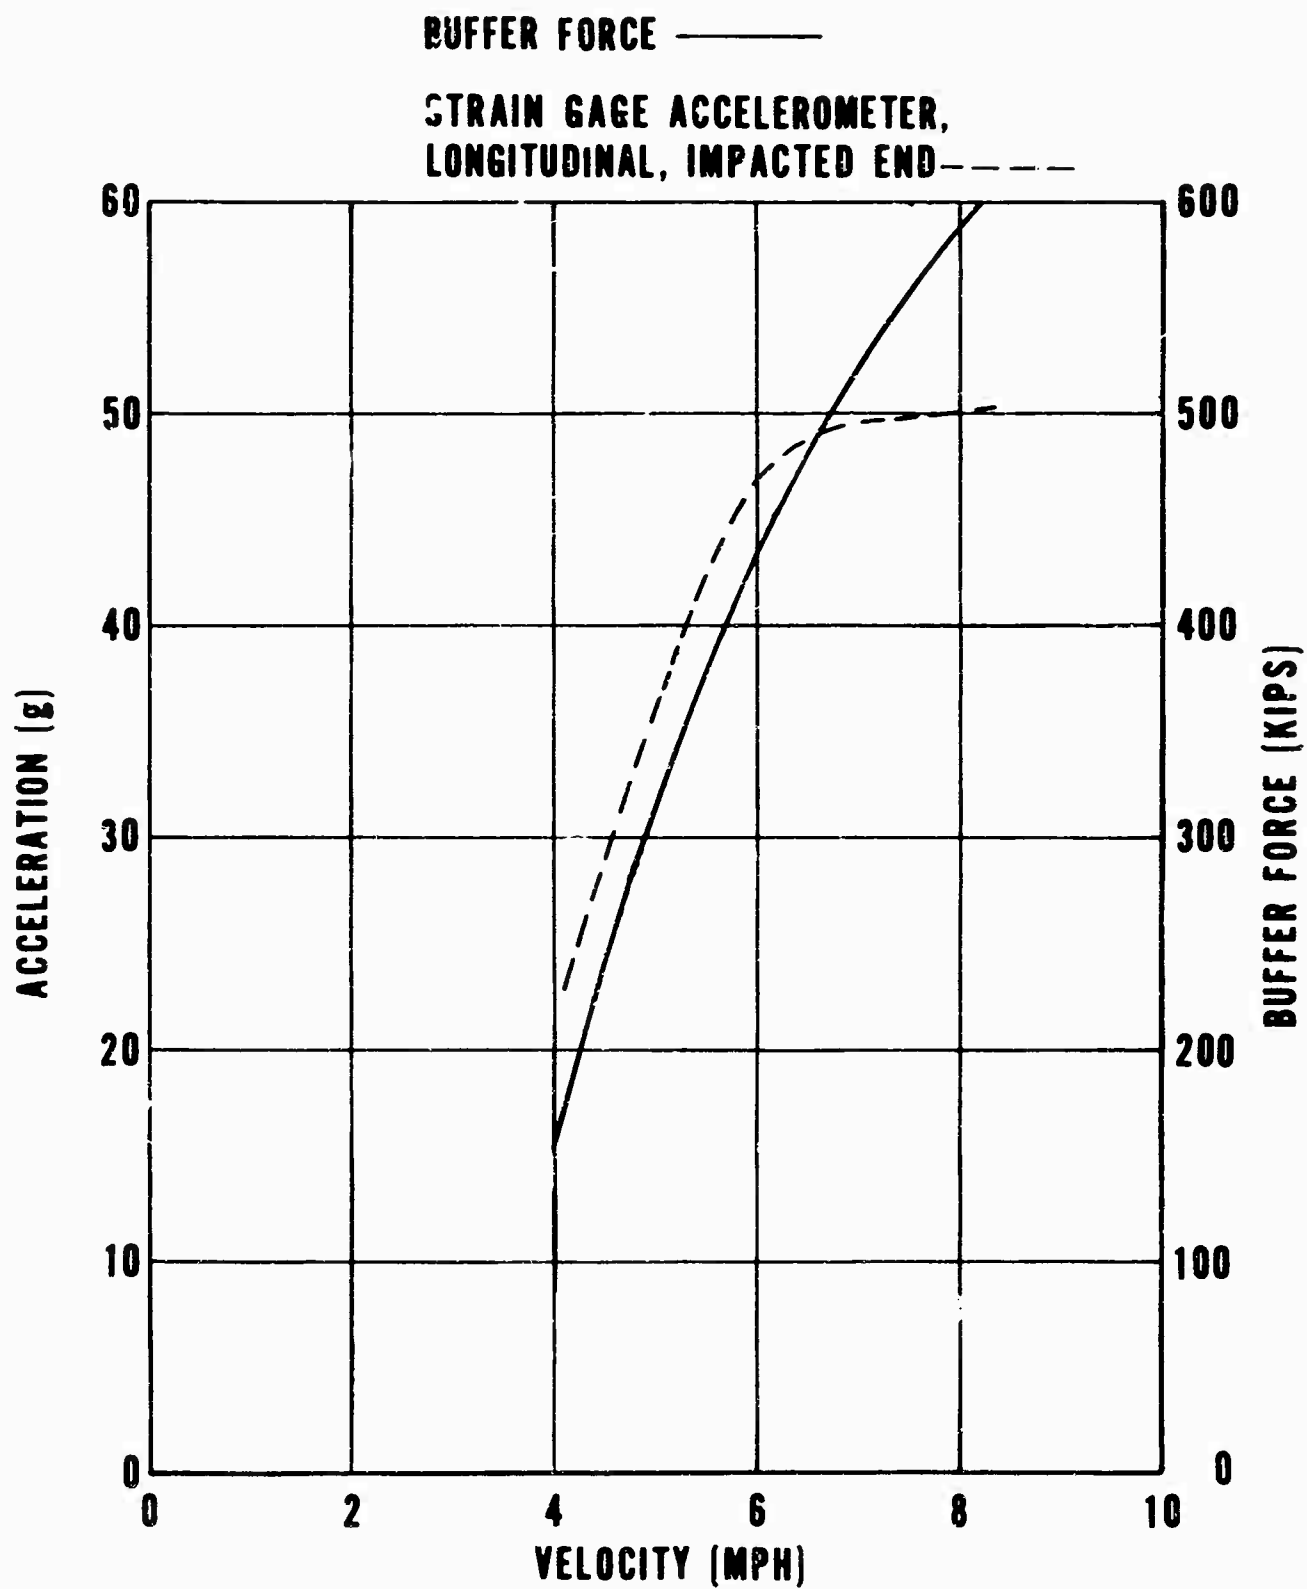
Figure 12. Buffer Force Versus Longitudinal Acceleration (Car Floor).

The side buffer force for the various impacts is presented graphically in Figure 12. Also, correlation is made between buffer force and the recorded car floor longitudinal accelerations. The car floor accelerations become asymptotic at a velocity of 6 miles per hour; therefore, recorded values above 6 miles per hour have no significant meaning. The accelerations on the car floor above 6 miles per hour exceeded the rated capacity of the accelerometer.

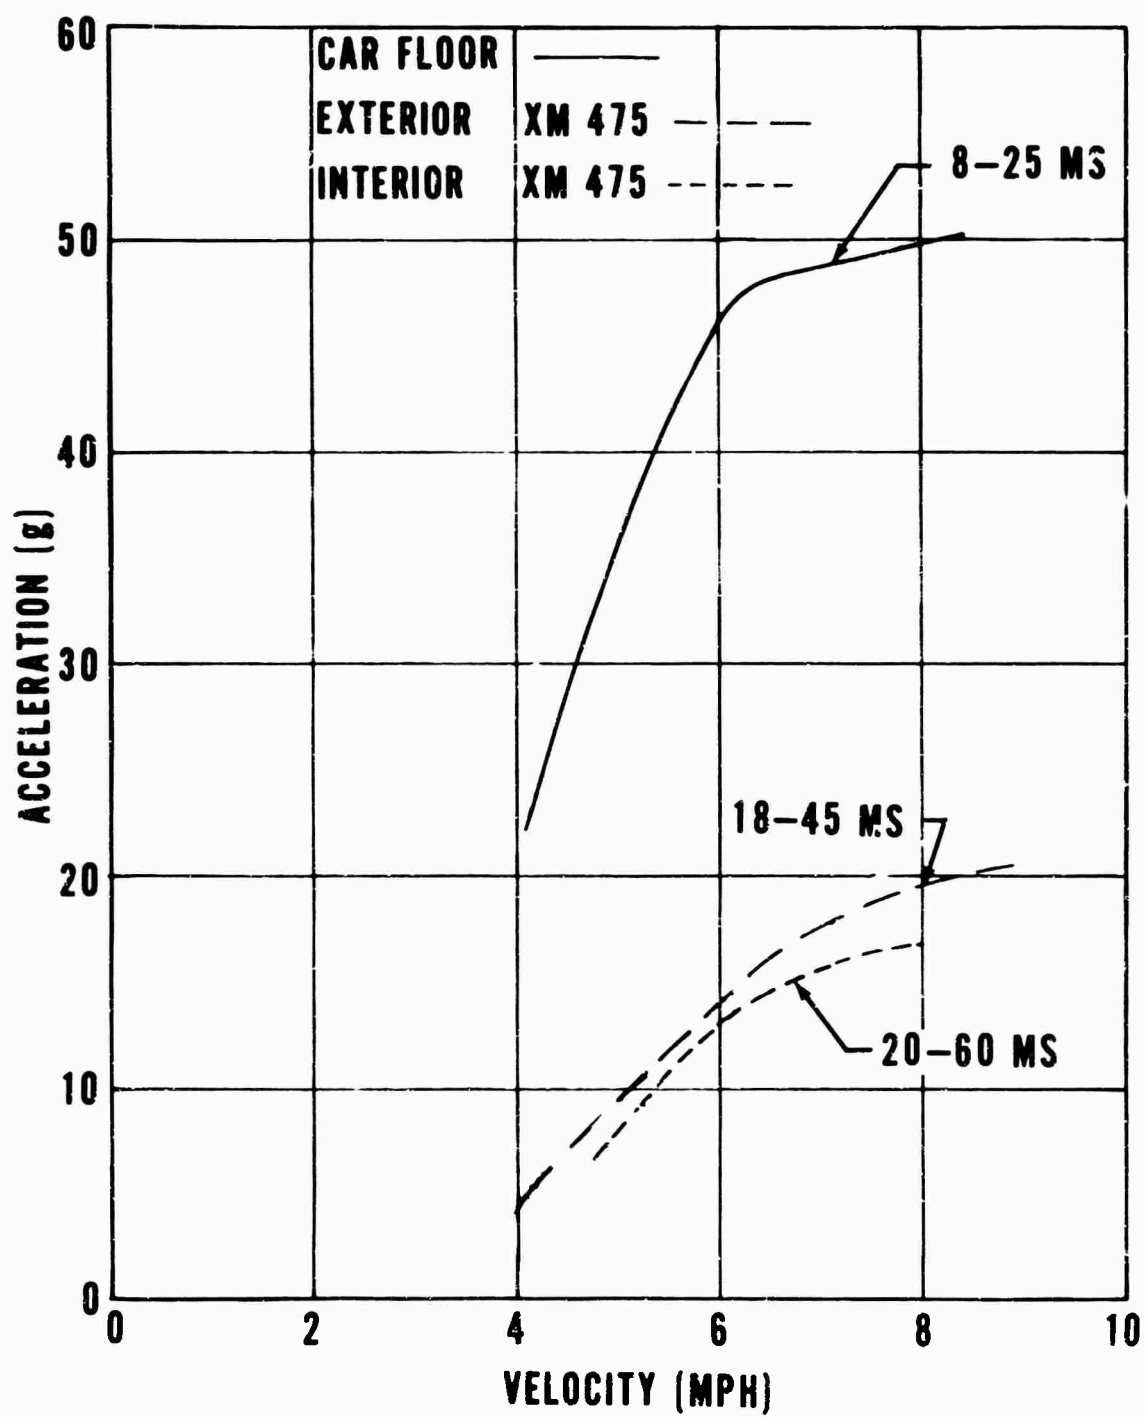
Figure 13. Longitudinal Accelerations - Car Floor and Exterior and Interior of XM 475 (XM 475 on Impacted End of Car).

The longitudinal, vertical, and transverse peak values recorded on the XM 475 container, exterior and interior, during Condition A are compared in Figures 13-15. Figure 13 indicates that the longitudinal responses of the container, exterior and interior, are similar up to about a 6-mile-per-hour impact velocity. Above that velocity, the carriage suspension system provides only a small gain in the shock attenuation up to impact velocities of 8.5 miles per hour. Figure 14 shows, however, that the carriage suspension system does effectively attenuate the imposed vertical accelerations. The transverse results (Figure 15) show that maximum attenuation is obtained at an impact velocity of approximately 6 miles per hour; and that, at higher impacts, the behavior of the carriage assumes an erratic response.

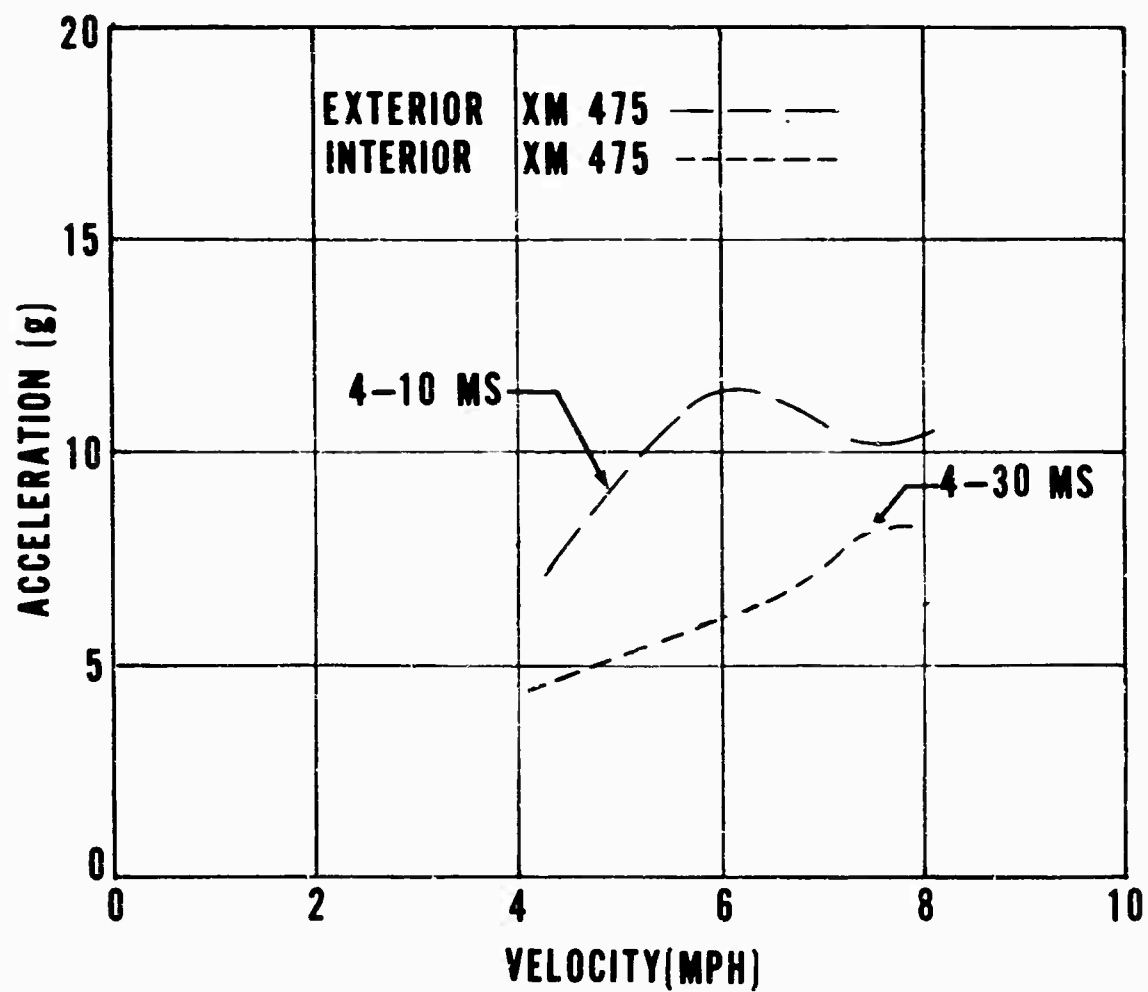
Figure 15. Transverse Accelerations - Exterior and Interior of XM 475 (XM 475 on Impacted End of Car).

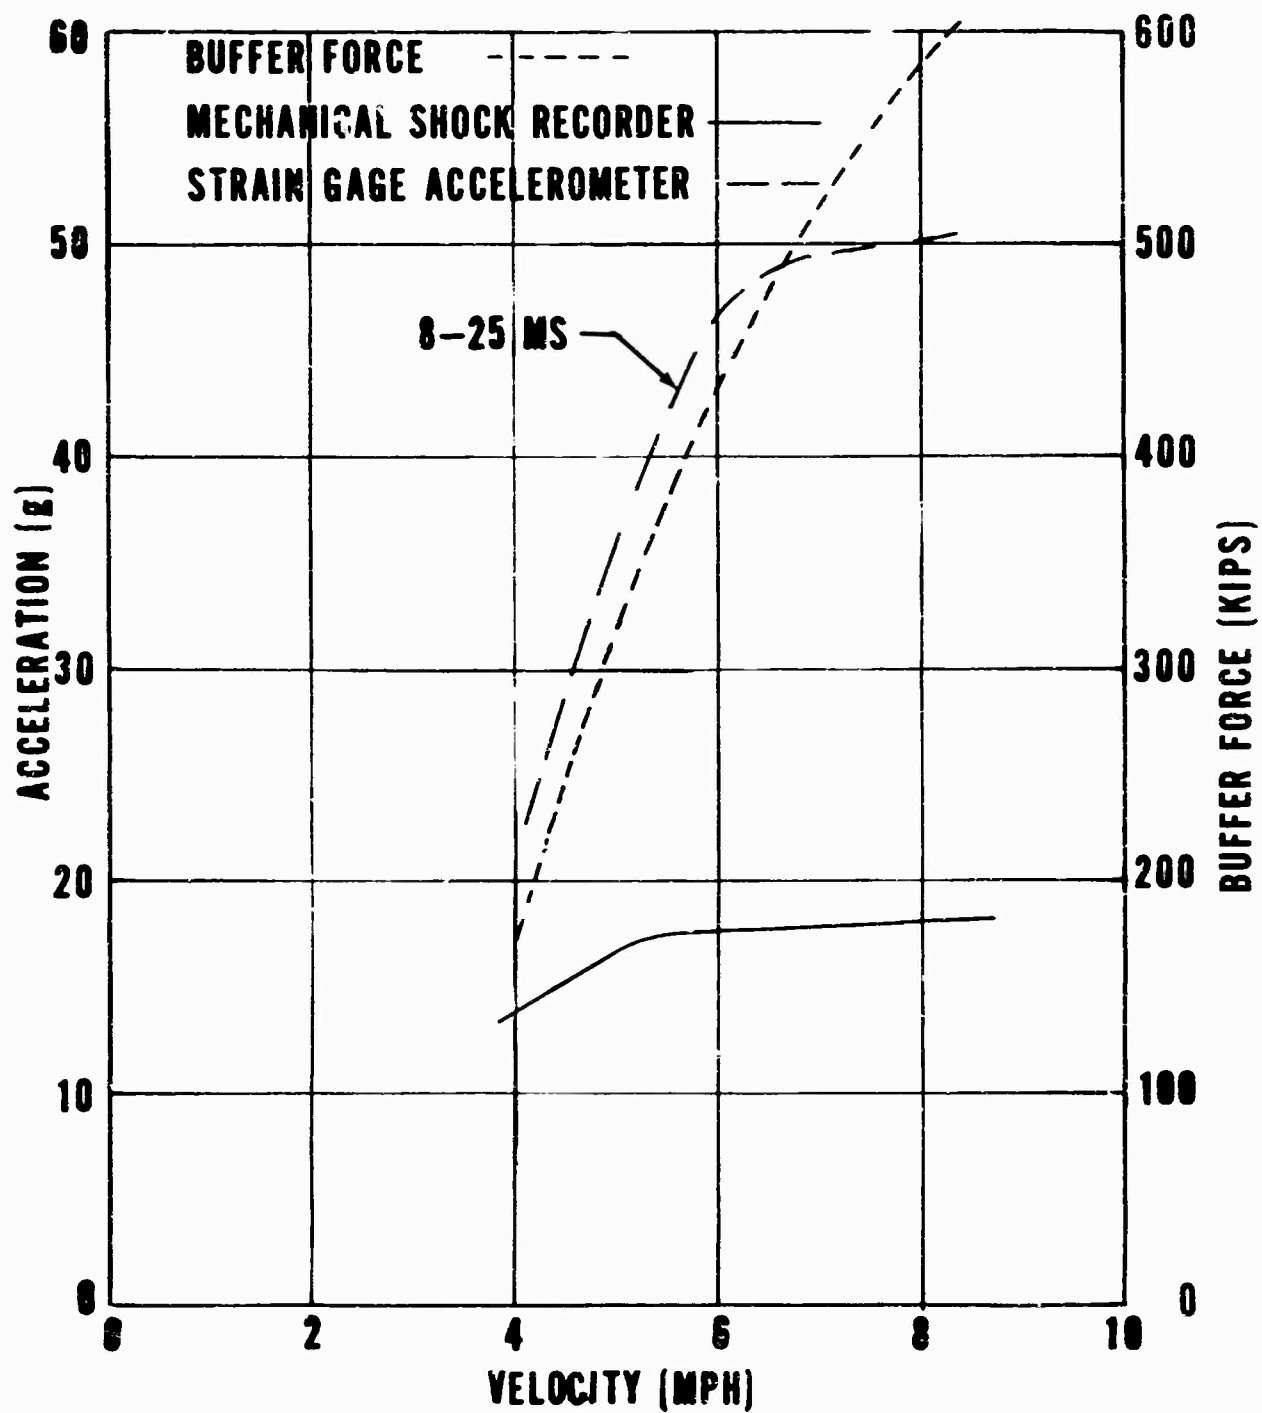
Figure 16. Longitudinal Accelerations on Car Floor: Mechanical Shock Recorder Versus Strain Gage Accelerometer (Instruments on Impacted End of Car).

Results of the electronic and mechanical recording systems located on the car floor and oriented longitudinally are compared in Figure 16. The figure shows that a correlation between the electronic and the mechanical recording systems at impact velocities above 5 miles per hour cannot be obtained, and that the maximum capacity of the mechanical recording system is approximately 18g. The mechanical recording system located on the exterior of the XM 475 container recorded in a similar manner.

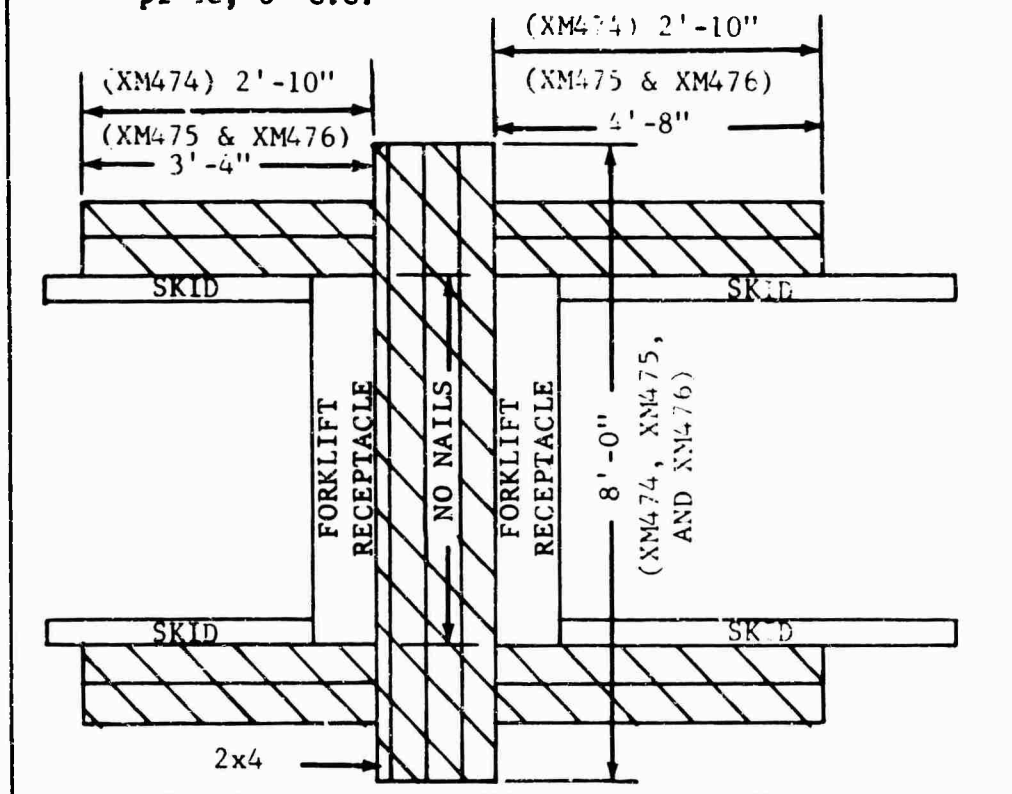
1. Blocking material will consist of hardwood, spruce, fir, larch, hemlock or dense southern yellow pine of the following species: longleaf, slash and/or loblolly, straight grained, free from decay and strength impairing knots.
2. Blocking is X-hatched. All doubled 2x6s except 2x4 filler, 30d nails bottom piece, 60d top piece, 6" C.C.

Figure 17. Distributed Uniform Loading Arrangement for the XM 474, XM 475, and XM 476 Containers.

A distributed uniform loading arrangement that is applicable to the XM 474, XM 475, and XM 476 containers was developed. See Figures 17 and 18. In addition to replacing the many arrangements depicted in Savanna Army Depot Drawing No. 5425, the arrangement shown in Figures 17 and 18 offers the following advantages over the arrangement illustrated in Figure 11:

1. Prepositioning of the transverse blocking is not required, since no nails are required under the container.
2. Less longitudinal space on the car is required.
3. The longitudinal blocking members also provide transverse restraint, which simplifies the arrangement.

In view of its simplicity and the other advantages enumerated, the restraining arrangement illustrated in Figures 17 and 18 is recommended for rail shipment of the XM 474, XM 475, and XM 476 containers.
